Safety Glazing

by Douglas Hansen

(this article last updated October 19, 2011)

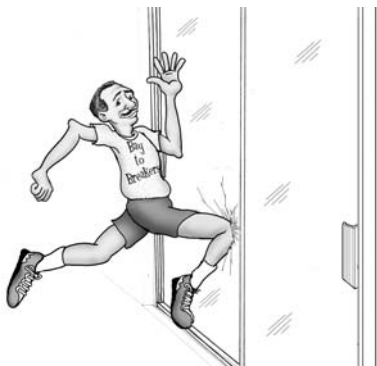
When a person accidentally impacts glass, there are two immediate dangers. The first is from lacerations due to the large shards that might slice into the person. There have been numerous instances of persons who have died from injuries such as a severed femoral artery (*figure 1*). Unless pressure is brought to bear immediately on such a wound, the victim can bleed to death in as little as five minutes. The second danger is from the “rebound” effect. The first reaction to impacting glass is to pull back. By then the glass is broken, and during the rebound, the person is pulling away from the sharp broken edges. The result can be deep lacerations that tear off large flaps of skin along with possible deep tissue damage..

Figure 1 – Impact with patio door

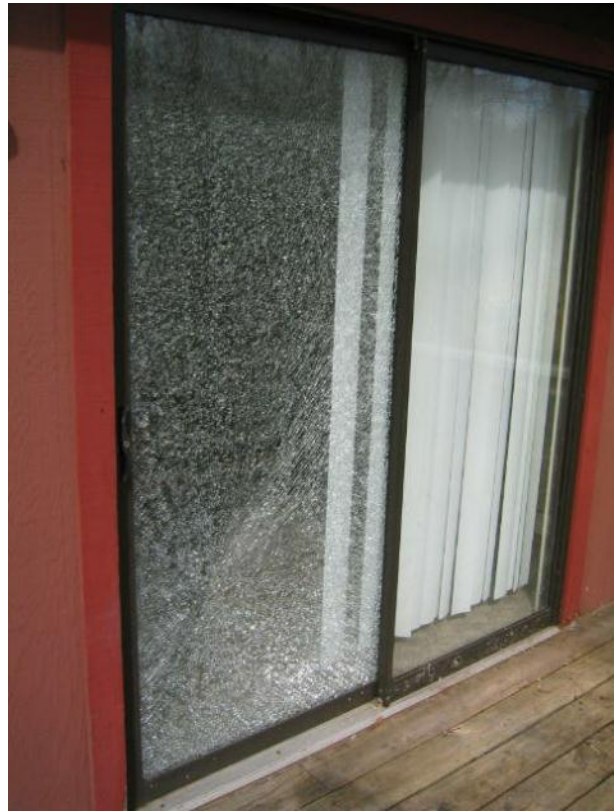
Tempered glass (used in the rest of the car windows) is created during manufacture by rapidly cooling the outer surfaces of a piece of glass while the inner portion, sandwiched between the outer layers, remains viscous. After final cooling, the inner portion of the glass is in tension while the surfaces are in compression. The result is a piece of glass that is four times more resistant to impact than annealed glass. When tempered glass breaks, it fractures perpendicular to the plane of the surface, rather than parallel to it, resulting in harmless small cubes that are less likely to cause significant injury (*figure 3*).

Figure 3 – Broken tempered glass patio door

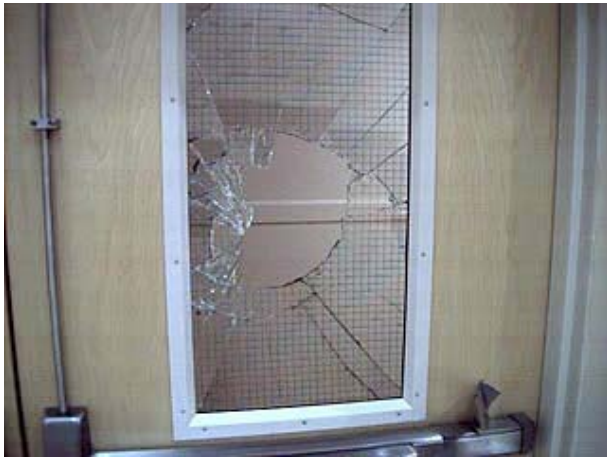
Greg Abel, founder of the Advocates for Safe Glass, came to this issue in a personal way. His son sustained a serious injury from wired glass at his school basketball court (figure 4). Sadly, this story is not unusual; approximately 2,500 such injuries occur each year in elementary schools alone. Mr. Abel founded a nonprofit organization to raise awareness of this issue and to lobby for enforcement of requirements for impact resistance. Why did we allow glass that does not meet impact resistance standards in doors and other public areas? A long protracted lawsuit from the wired glass manufacturers (all based offshore) tied up the CPSC and resulted in exceptions that remained in the building codes for decades. Fortunately, Mr. Abel's long efforts on behalf of public safety eventually paid off with successful amendments to the 2006 codes, and wired glass not meeting the CPSC standard is no longer allowed in locations subject to impact.

Figure 4 – Vision pane in gymnasium door

Wired glass is commonly used in “vision panes” of swinging doors to allow someone to see persons on the other side. This violates the original CPSC standard, but was allowed until quite recently; when the choice has been between glass with a fire rating, or glass with a proper safety rating, the fire rating has taken precedence.

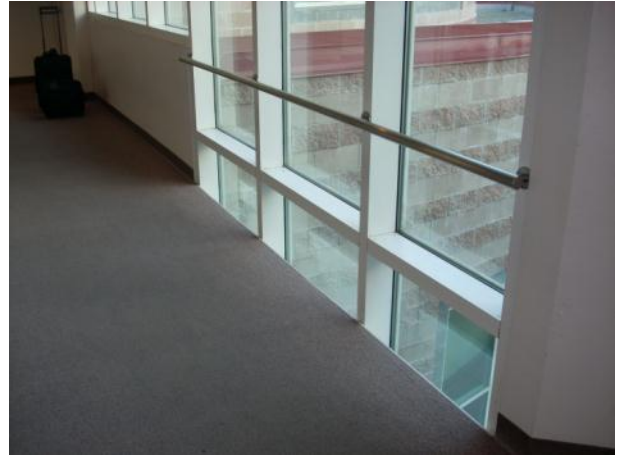
For these windows, there are exceptions for decorative glass, as well as an exception when a protective bar is installed within 34 – 38 inches above the floor, and the bar can withstand a horizontal load of 50 pounds per foot without contacting the glass (*figure 7*). The cross-sectional height of the bar must be at least 1½ inches.

Figure 7 – Protective bar in front of window

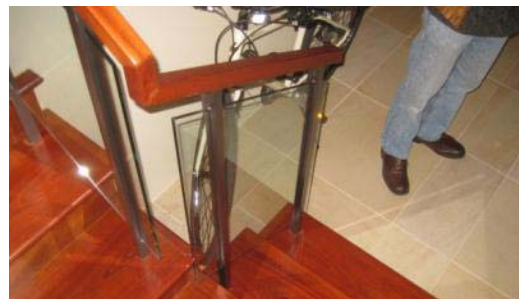
4) Guards and Railings. All glass in railings and guards is required to be safety glass, regardless of height above the walking surface. Laminated glass is usually chosen for these locations (*figure 8*).

Figure 8 – Laminated glass in guard infill

Laminated glass has two separate pieces of annealed, heat-strengthened, or tempered glass sandwiched around a layer of clear polyvinyl butyryl (PVB). It was invented just over 100 years ago. The layers are bonded under high pressure. In the United States, it is used in car windshields. It is a safety glass product. One side can shatter from impact without the other side shattering, and when the glass shatters it does not delaminate into shards. Laminated glass is often used for frameless glass railings (figure 8).

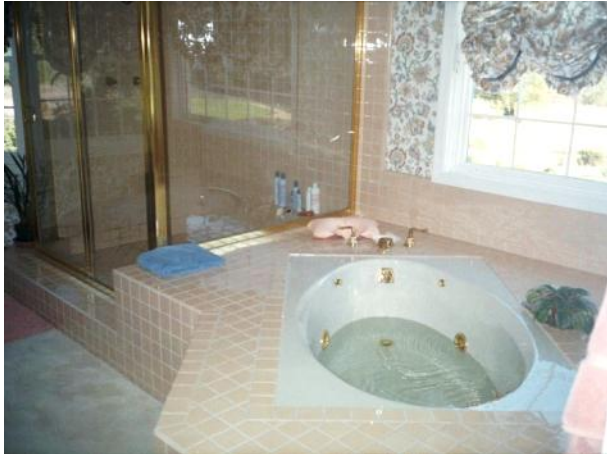
5) Wet Surfaces. Glazing in walls, doors, and enclosures for showers, tubs, saunas, whirlpools, steam rooms, spas, hot tubs, and indoor or outdoor swimming pools must be safety glass. The rule applies whenever the bottom exposed edge of the glazing is less than 60 inches above any standing or walking surface. In earlier editions of some codes, the “standing surface” was considered to be the drain inlet level of the tub or shower. Many tubs today (especially whirlpools) have adjacent surfaces which could serve as a step or other area to stand upon, and the 60-inch measurement should begin at those surfaces (*figure 9*).

Figure 9 – Whirlpool tub with adjacent window

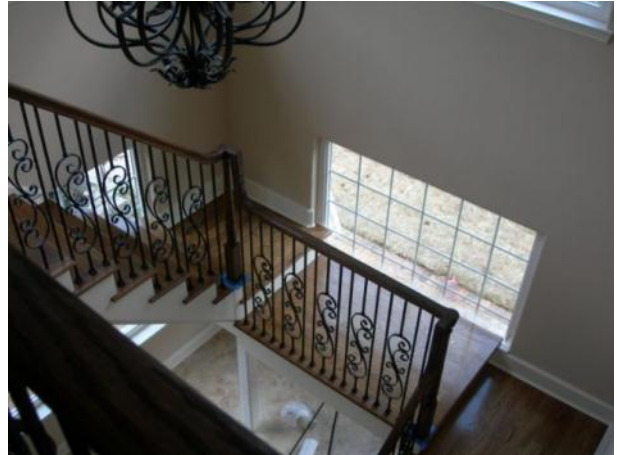
7) Bottom Stair Landing. Glazing adjacent to the bottom landing of stairs must be safety glass when it is within 60 inches horizontally of the bottom stair

tread and less than 36 inches above the landing (*figure 10*). The idea here is that a person falling down the stairs will roll into the landing. There is an exception for guards that intervene between the landing and the glass and are at least 18 inches from the glass.

Figure 10 – Glass in stair landing

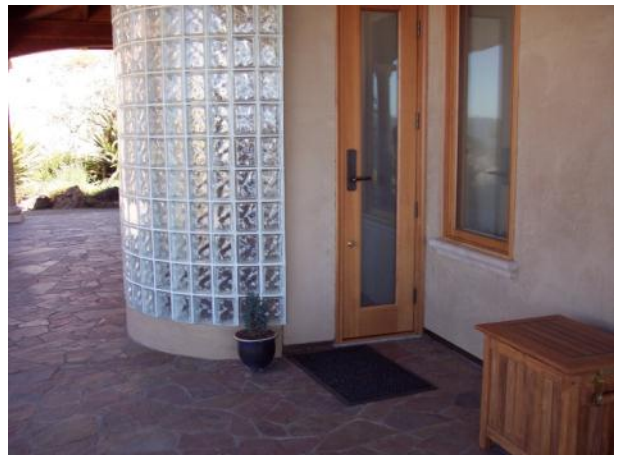
Glass unit masonry that is properly installed is exempt from safety glazing rules, even in showers (*figure 11*). Many of these are made with acrylics. The top and bottom courses must be secured, and they cannot bear any other loads.

Figure 11 – Glass unit masonry enclosing shower. Note that the sidelite at the right would not require safety glass if the door were hinged on the other side.

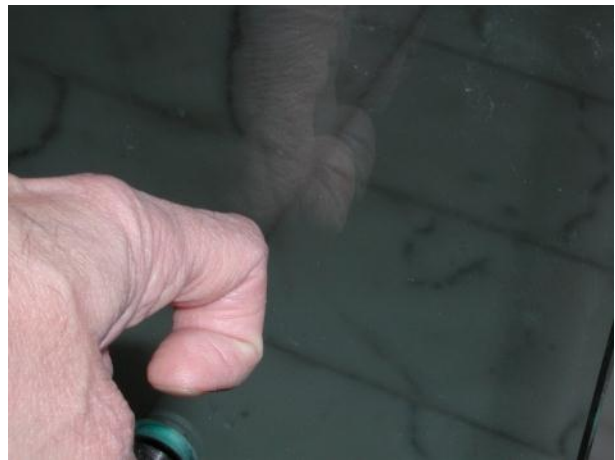
Laminated glass is sometimes labeled, though most codes do not require it. When it is labeled, the reference on the bug will typically be to DOT – the Department of Transportation. Laminated glass can be identified by the reflection in the glass – if you hold your hand to it, you will see multiple reflections. With a little practice, these are readily distinguishable from the two reflections you might see from the inner and outer surfaces of a piece of non-laminated glass (figure 12).

Figure 12 – Laminated glass reflections

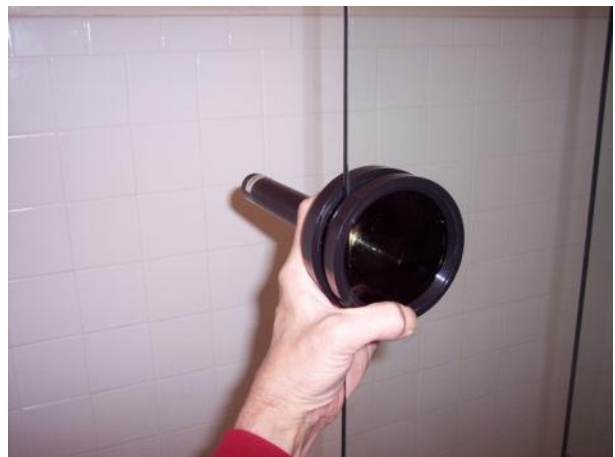
Inspectors are often baffled by glass that has a frame obscuring the label, or in the case of shower doors, a soap or hard-water residue obscuring the glass. It is possible to verify that tempered glass is present by using a pair of polarized light lenses. Normally, if you hold two such lenses over your flashlight, and rotate the lenses to where their polarities are at 90 degrees to each other, all light will be blocked. If you do this with a pane of tempered glass between them, distinctive black lines will appear as you rotate the lenses toward total blackness (figure 13).

Figure 13 – Polarized light testing

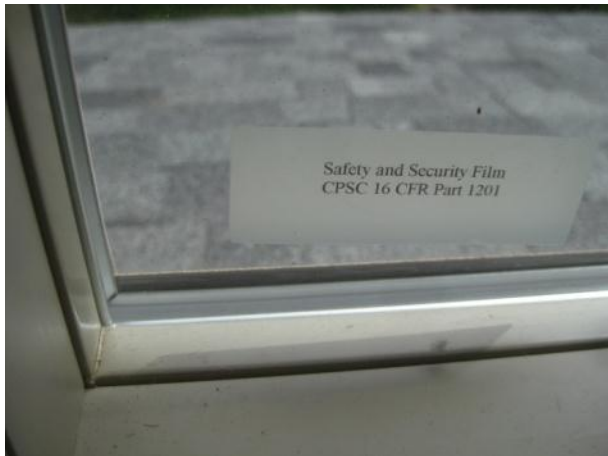
Thousands of houses built in the 50s through the 70s have large floor-to-ceiling windows of ordinary glass, or have patio doors that are not safety glass. In lieu of replacement, it is possible to strengthen these doors and windows with products such as Scotchshield™ safety film from 3M. Applied properly, the material is durable, effective, and not noticeable. An installer can apply a label self-certifying that the glass complies with the CPSC standard (figure 14). ICC Evaluation Service legacy report 94-41 states that the product does qualify as safety glass when properly installed. Many jurisdictions accept this, and the label is not likely to be present with a homeowner-applied film. Inspectors can generally tell if film is present because there will be a slight gap at the edges of the glass.

Figure 14 – Security film label

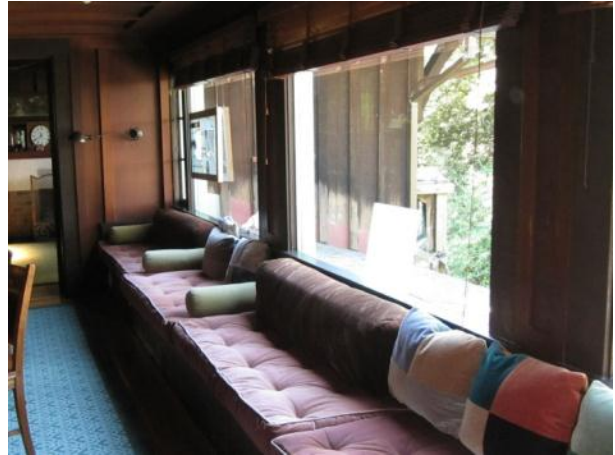
Though window seats might be designed with cushions and pose an invitation for persons to lean on the glass, safety glazing is not required (figure 15). Large pieces of glass that do not meet all the conditions of item 3 could still become flying shrapnel in high winds or in earthquakes. A home inspector in Virginia once was a party to an injury where a double-hung window with a broken sash cord fell and sent a piece of glass flying into a child, who barely survived. Safety glass is not required in cabinet doors. Fireplace doors are required to be impact and heat resistant per UL

Figure 15 – Window seat
